Advisory Note –

Potential safety hazard with Trelchem VPS FLASH

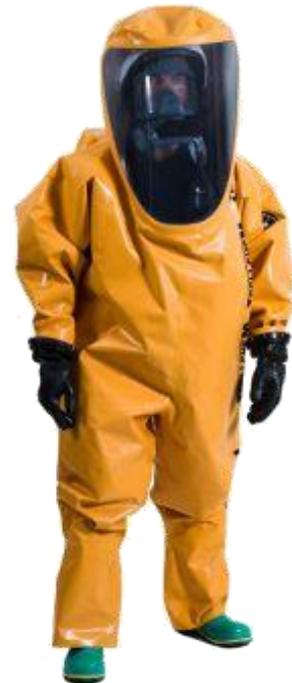
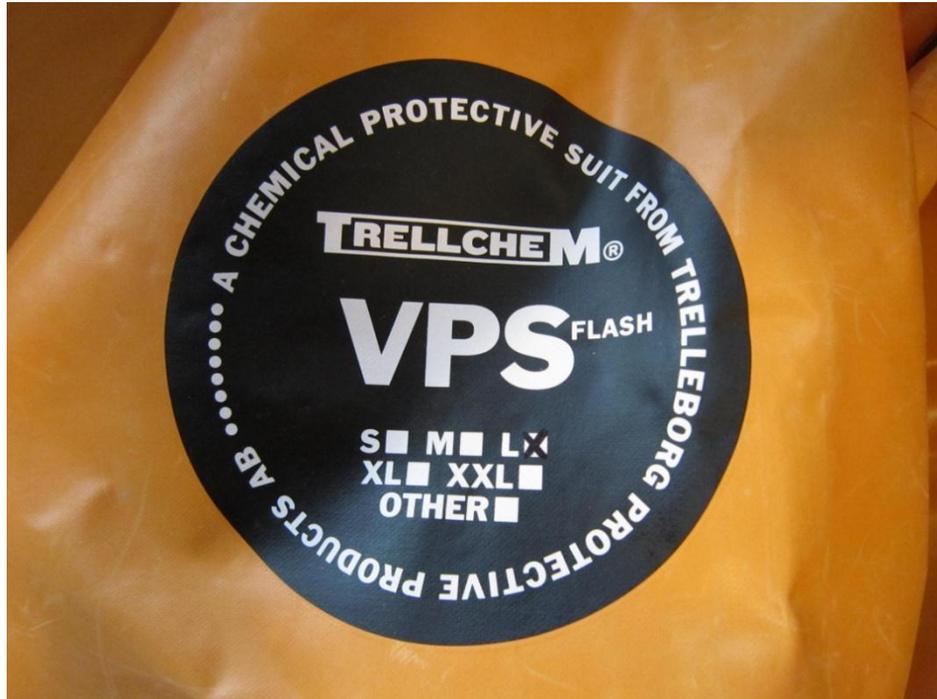
Please note that this advisory note only applies to Trelchem VPS FLASH types CV and VP1 i.e. totally encapsulating suits with visors. No other Trelchem suits are affected. See images below to identify Trelchem VPS FLASH suits.

Trellchem VPS FLASH suits can be identified using the left sleeve label.
