IMPORTANT SAFETY NOTICE

To: **All Users of Sperian Warrior Self-Contained Breathing Apparatus (SCBA)**

The purpose of this Important Safety Notice is to advise you of a potential safety issue with the Rapid Intervention Crew/Company Universal Air Connection (RIC UAC, hereafter referred to as the UAC) used in Sperian Warrior SCBAs.

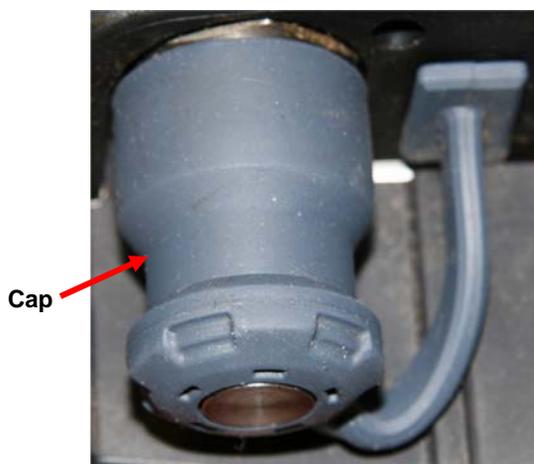
Figure 1

Under some conditions, it is possible to pull the protective dust cap off the pin in the pin-and-cap assembly, resulting in the pin remaining stuck in the UAC coupling. If the cap has separated from the assembly, the pin stuck in the coupling would prevent the coupling from functioning in a rapid intervention scenario.

This condition can occur when the pin has not been removed from the coupling for a long time. There is an internal o-ring in the coupling that seals against the pin. If the pin has not been "exercised" by removing it from the coupling periodically, it can take a set (become stuck) against the o-ring. The amount of force necessary to then remove the pin-and-cap assembly from the coupling may exceed the ability of the cap to remain attached to the pin, and the cap may separate from the pin.

1. Attempt to remove the pin-and-cap assembly from the UAC coupling (see Figures 1 and 2).

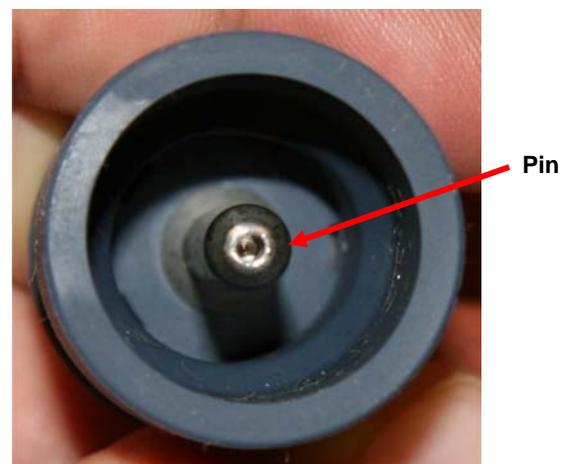
Figure 2

This condition can also occur if the pin has been bent during use.

2. If the pin-and-cap assembly can be removed from the UAC coupling, inspect the pin to ensure that it is not bent (see Figure 2). If it is bent, contact your local Sperian Warranty Service Center to have a Sperian-certified technician replace the pin-and-cap assembly (Sperian part number 975641) on the Warrior; then follow the lubricating procedure in Step 3 below.
3. If the pin is not bent, use a cotton swab to apply a **thin** coat of Molykote 33 Light (Sperian part number 820489) to the sides of the pin shaft from just below the tip of the pin to approximately ¼-inch below the tip of the pin. Do not overlubricate. Do not apply Molykote 33 Light to the tip of the pin. Ensure that the cotton swab does not deposit any lint on the pin shaft. You do not need to be a Sperian-certified technician to apply Molykote 33 Light to the UAC pin.
