Safety Advisory

G1 SCBA & RIT System – High Pressure Relief Valve

January 13, 2017

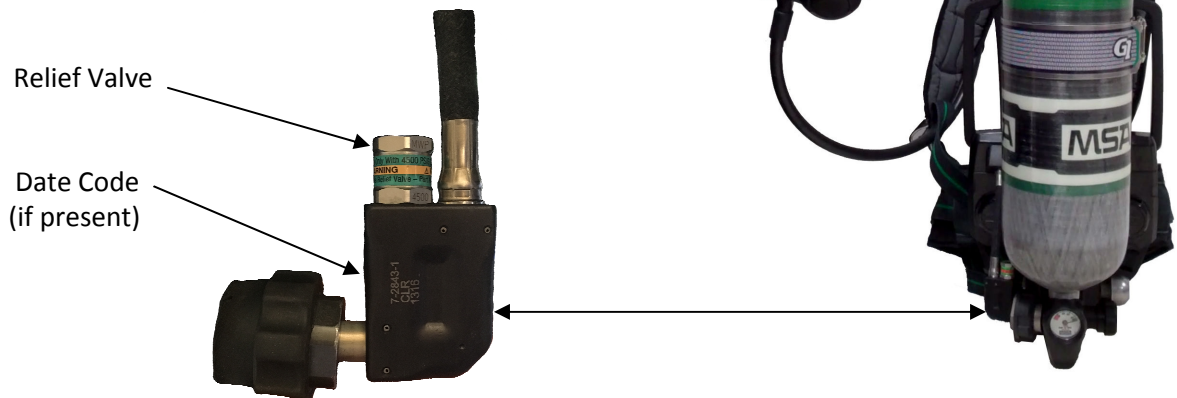
Service is required to re-torque the high pressure relief valve on all 4500 psig G1 SCBA with a manufacturing date code before '5016' (50th week of 2016) and also on SCBA and RIT Systems with no date code. If the SCBA date code is present, it is marked on the hand wheel assembly as shown in the photo below. The service must be performed by an MSA certified CARE technician and will be free of charge. 2216 psig SCBA and RIT Systems do not require this service.

Please contact your local MSA Fire Service Distributor to arrange for this re-torquing service as soon as possible. If you have an MSA certified CARE technician on staff, they may perform this service. For identification purposes, SCBA serviced to re-torque the relief valve will be marked with a center punch mark on the hand wheel manifold as shown in the photo below. A similar mark will identify RIT Systems. New production will not have the punch mark.
