Immediate Action Required User Safety Notice SN052022

3M™ Scott™ Air-Pak™ X3, Air-Pak™ X3 Pro, and X3-21 Pro Self-Contained Breathing Apparatus

November 1, 2019 – April 12, 2022

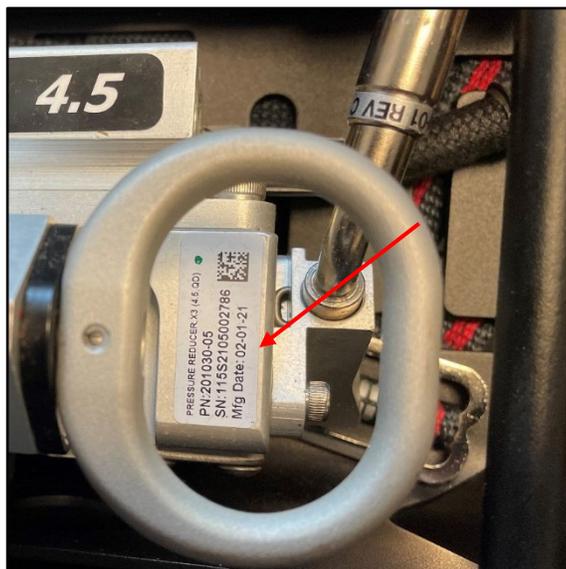
Figure 1

To confirm that you have an SCBA included in this User Safety Notice, please verify that your Air Pak X3, X3 Pro, or X3-21 Pro SCBA reducer was manufactured between 11/01/2019 and 04/12/2022. Reference **Figure 1** for an example of how to identify the mfg. date of your pressure reducer (the location and format of the serial number label is identical on all models).

If your Air-Pak X3 SCBA is included in this Notice please contact your 3M Scott Authorized Service Center, or 3M Scott Technical Support so that a service professional can assist you in scheduling the completion of the Notice. Your 3M Scott Authorized Service Center or 3M Scott Distributor has received your shipment data and should contact you as well. 3M Scott Technical Support can be contacted at 1-800-247-7257, or scotttechsupport@3m.com, or through the web at www.3M.com/ScottFire.
