User Notice

Universal Rescue Connection

July 17, 2008

URC Male Coupling Tightness Inspection Procedure

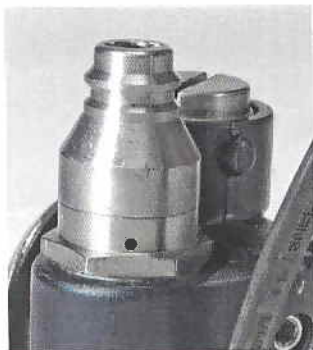
FIGURE 1
Typical Assembly

1. Close the air mask cylinder valve and relieve the pressure from the system.
2. Using a fine-tip ink marker and a ruler or straight edge, draw a line on the male coupling extending across the coupling joint and onto the adjacent air mask housing, as indicated in the photos below.
3. Attach the dust cover to the coupling.
4. Grasp the dust cover firmly by hand and using maximum effort attempt to loosen the coupling by turning the dust cover counterclockwise. Do not use tools.
5. Remove the dust cover.

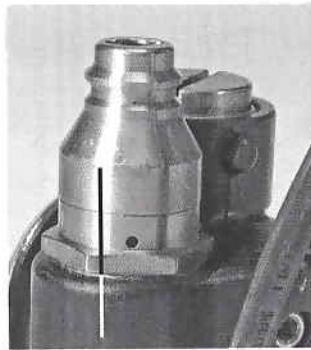
FIGURE 2
Tight

Tight: If the line drawn on the coupling lines up (see Figure 2), the coupling is sufficiently tight and the air mask may be returned to service.

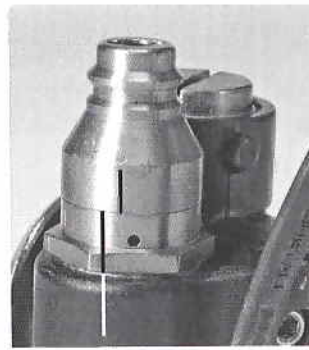
FIGURE 3
Loose at Coupling Joint

Loose at Coupling Joint: If the coupling is loose or if the marked line does not line up across the coupling joint (see Figure 3), remove the air mask from service until a replacement coupling is installed.

If any loose couplings are discovered after performing the initial inspection, please complete the attached form and forward it to your local MSA authorized air mask maintenance center to arrange for the coupling to be replaced free of charge. Only MSA certified repair persons are authorized to remove or install a URC coupling. In order to provide quick service, a replacement coupling of similar or newer vintage will be installed.

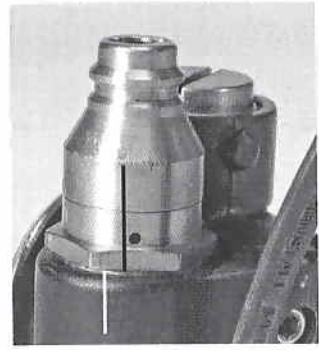
FIGURE 4
Loose at Manifold

Loose at Manifold: If the coupling is loose at the joint where the coupling attaches to the air mask (see Figure 4), remove the air mask from service until the coupling is inspected by and MSA certified repair person.

Note: Only authorized MSA or Aeroquip personnel should re-tighten the coupling.
