Important Safety Notice Concerning SCOTT HUD Quick Disconnect Hoses

DATE: 29 August 2008

TO: All Users of SCOTT® AIR-PAK® 50, AIR-PAK 75, NxG2, and NxG7
Self-Contained Breathing Apparatus equipped with Heads-up Display (HUD)

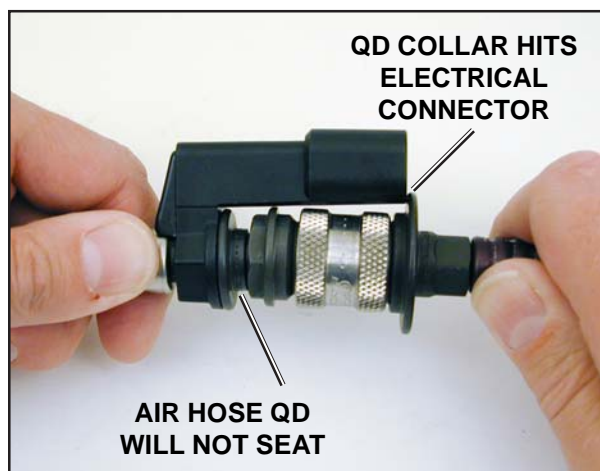
Changes to the length of the electrical connector between the 2002 and 2007 editions have resulted in clearance issues between the new connector and certain auxiliary hose fittings on SCOTT manufactured air sources in the field. See FIGURE 2.

FIGURE 2 – Unacceptable Fit UNMODIFIED LONG CONNECTOR
(Note Interference Between Collar and Connector)

A corrective action was instituted to modify the new long connectors with a notch. But some hoses with the UNMODIFIED long connectors are in the field and must be replaced. Only the UNMODIFIED long connectors with NO NOTCH are subject to this safety notice.

Replacing the low pressure hose with one equipped a modified long connector will eliminate the potential clearance problem. This hose assembly will be made available at no charge to those users and will be provided to the authorized service center for installation.

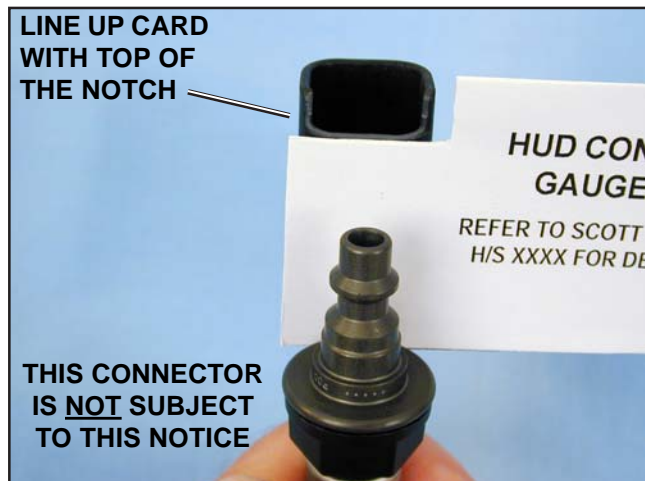
If the GAUGE CARD lines up with the NOTCH as shown in FIGURE 6, this low pressure hose is NOT subject to the notice.

**FIGURE 6 – Modified Long Connector with NOTCH
NOT SUBJECT TO THIS NOTICE**
