User Inspection Advisory

UEBSS Fitting

February 2025

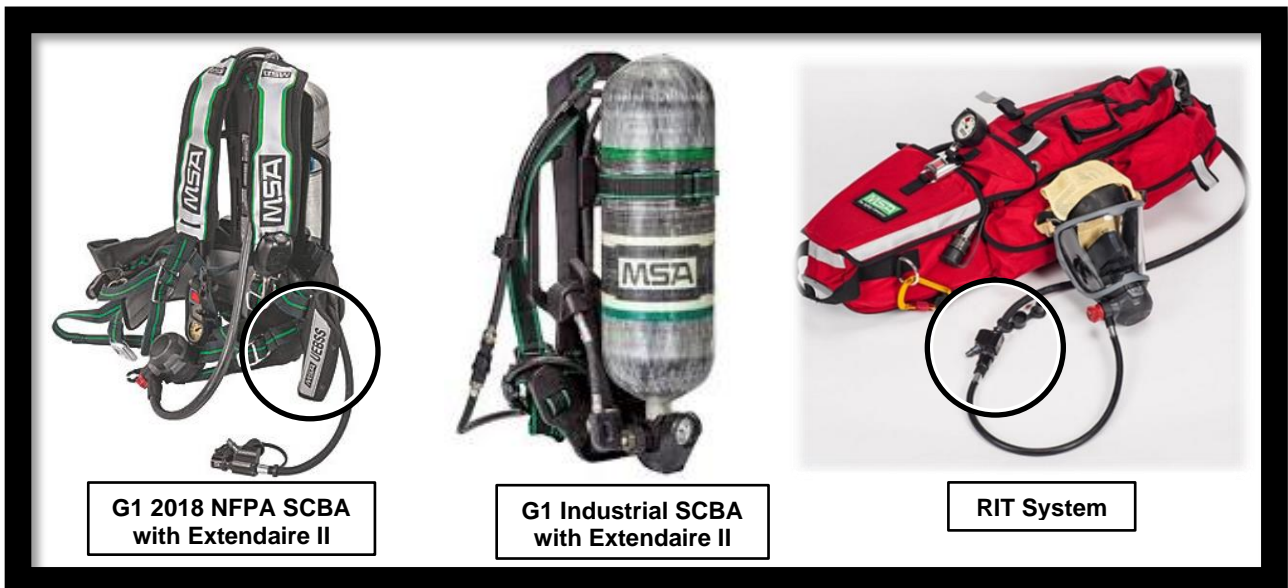
Figure 1: Affected Products

MSA products affected by this advisory:

G1 2018 NFPA SCBAs with Extendaire II

G1 Industrial SCBAs with Extendaire II

RIT Systems

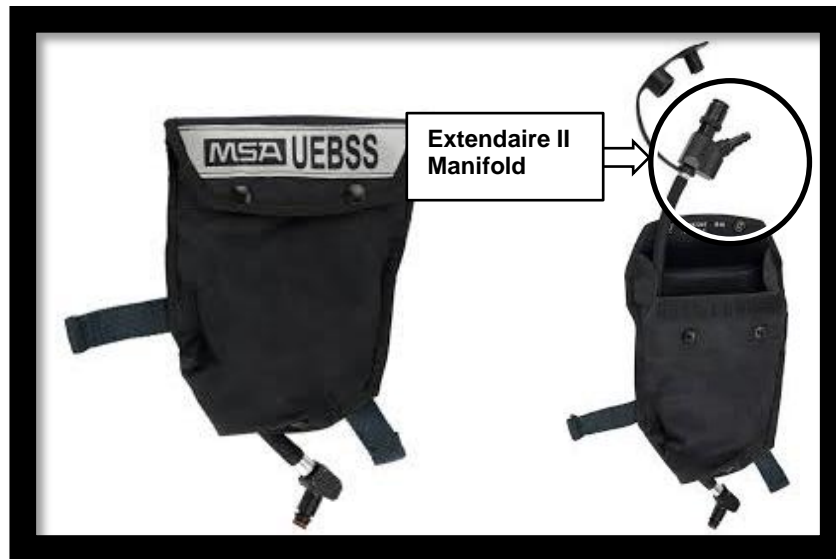
Figure 2: UEBSS Pouch

- a. If your device is **equipped with a pouch with the lettering “UEBSS”** (Figure 2) → Your device is affected and must be inspected per this notice.
- b. You may also **locate the Part Number inscribed on the Extendaire II manifold** (Figure 3)
 - i. PN: 10186989 → Your device is affected and must be inspected per this notice.

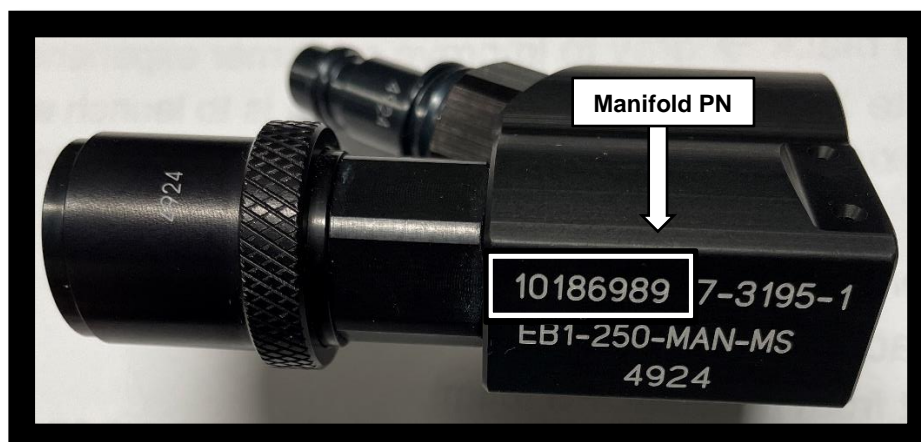
Figure 3: Extendaire II Manifold

- a. If your device is equipped with a pouch, take the hose out of the pouch and **locate the Part Number inscribed on the Extendaire II manifold**. (Figure 3)
 - i. PN: 10180955 → Your device is affected and must be inspected per this notice

- a. **Locate the Part Number inscribed on the Extendaire II manifold** (Figure 3)
 - i. PN: 10203476 → Your device is affected and must be inspected per this notice.

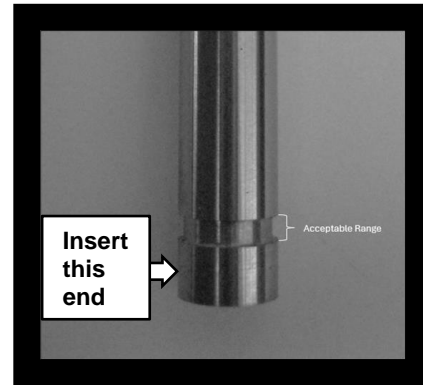
Figure 4: Custom Pin Gauge

This inspection procedure requires a custom pin gauge (Figure 4). **Please contact your channel partner to obtain the pin gauge that is required for this inspection procedure.**

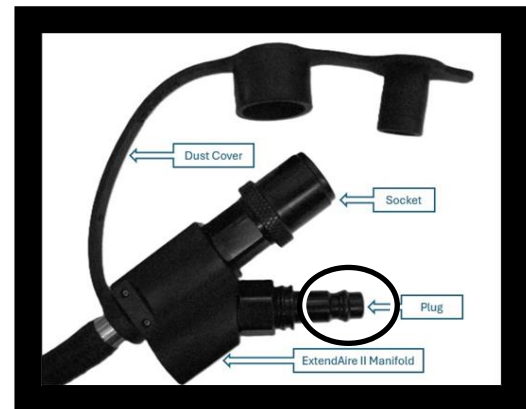
Figure 5: ExtendAire II manifold

1. **Locate the Plug** on the ExtendAire II manifold. (Figure 5)
2. **Insert the Pin Gauge** into the open port on the plug.
3. **Depress the valve using the Pin Gauge**
note: ensure the gauge has fully bottomed out in the fitting
4. **Visually inspect the depth of engagement** on the Pin Gauge.
 - a. If the **groove of the pin gauge is visible** (Figure 6a), the fitting is **acceptable**, and the unit can be returned to service.
 - b. If the **groove of the pin gauge is NOT visible** (Figure 6b), the fitting is **NOT acceptable**, please **remove the unit from service** and return the device to a certified repair technician.
