User Safety Notice

FireHawk[®] M7XT Air Mask

December 19, 2014

PS14033-02

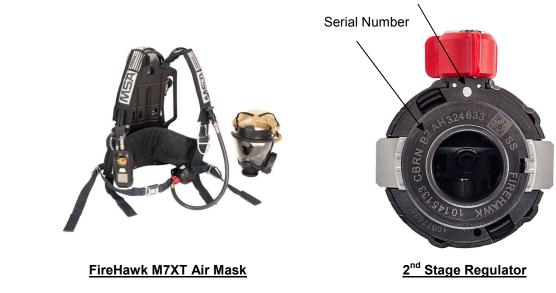
Marker Dot

Once the inspection, cleaning, and re-lubrication or component replacement is completed, the technician will mark the regulator with a dot (as shown in the photo below) using a permanent silver marker to identify that the repairs are completed.

Affected Air Masks have a second stage regulator with any of the 10 digit serial numbers according to the list below. The serial number is etched on the underside of the regulator body as shown in the photo below:

To correct this condition and ensure the proper functioning of the FireHawk M7XT Mask-Mounted Regulator bypass valve, we have arranged for MSA CARE certified SCBA repair technicians to inspect, clean, and re-lubricate the bypass valve assembly on all FireHawk M7XT Air Masks free of charge. If during the inspection, there are signs of wear due to lack of lubrication, the valve and bypass assemblies will be replaced free of charge.
